**Flood Control Project Maintenance
Levee Inspections**

2019 Channel Summary Report

DWR Sutter Maintenance Yard

Big Chico Creek

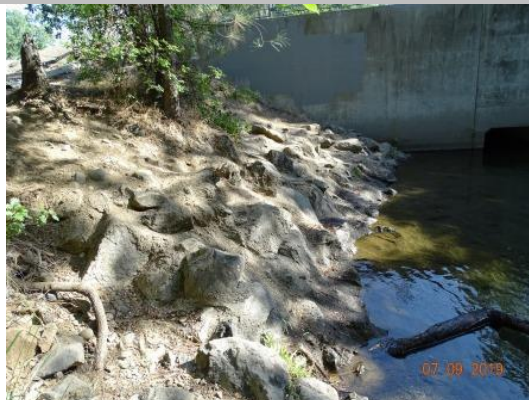
Photo 1 of 2 : CH_2019_NA0060_5_9_20190715_00032.jpg

Rating **	A	Issue No.	9	GPS Lat/Long
Issue Type +	Ma	Location *		39.761840 °
Category	Rivers, Channels & Designated Flood			-121.792590 °
Item	Revetments			
DWR ID	DWR_NA0060_5_c_2012_9			
Action/Comments				
Inspector Comments: Riprap is visible and appears properly maintained.

View of the revetment downstream right bank of the channel from the structure, 2019.

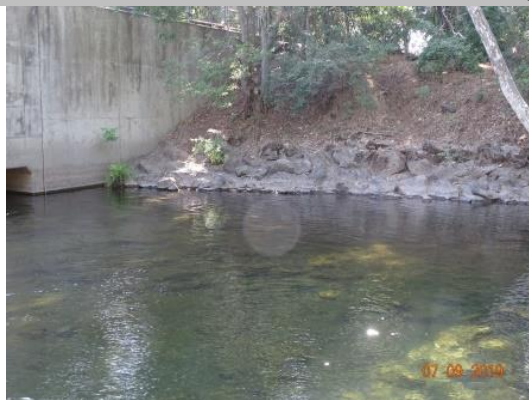
Photo 2 of 2 : CH_2019_NA0060_5_9_20190715_00031.jpg

View of the revetment downstream left bank of the channel from the structure, 2019.

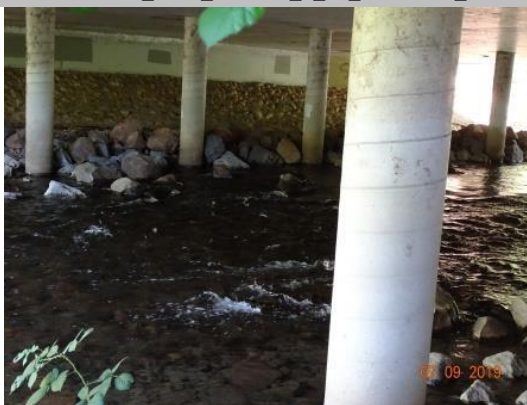
Photo 1 of 2 : CH_2019_NA0060_5_14_20190715_00036.jpg

Rating **	A	Issue No.	14	GPS Lat/Long
Issue Type +	Ma	Location *		39.758224 °
Category	Rivers, Channels & Designated Flood			-121.795853 °
Item	Revetments			
DWR ID	DWR_NA0060_5_c _ 2012_14			
Action/Comments				
Inspector Comments: Riprap is visible and appears properly maintained.

View looking upstream at the right bank of typical revetment around the abutment and bike path, 2019.

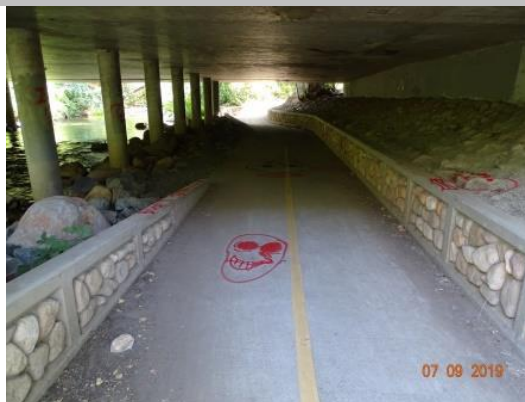
Photo 2 of 2 : CH_2019_NA0060_5_14_20190715_00035.jpg

Inspector Comments: Riprap is visible and appears properly maintained.

View looking upstream at the left bank of typical revetment around the abutment and bike path, 2019.

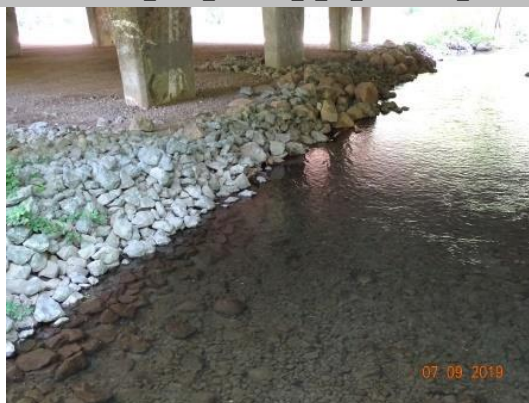
Photo 1 of 2 : CH_2019_NA0060_5_24_20190715_00040.jpg

Rating **	A	Issue No.	24	GPS Lat/Long
Issue Type +	Ma	Location *		39.738490 °
Category	Rivers, Channels & Designated Flood			-121.822810 °
Item	Revetments			
DWR ID	DWR_NA0060_5_c_2012_24			
Action/Comments				
Inspector Comments: Existing riprap protection is properly maintained and is undamaged. Riprap is clearly visible on both sides.

View of revetment along the channel right bank, looking upstream, 2019.

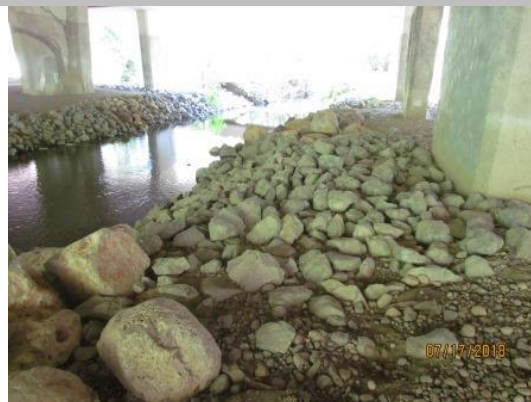
Photo 1 of 1 : CH_2019_NA0060_5_29_20190701_00015.jpg

Rating **	A	Issue No.	29	GPS Lat/Long
Issue Type +	Ma	Location *		39.738490 °
Category	Rivers, Channels & Designated Flood			-121.822810 °
Item	Revetments			
DWR ID	DWR_NA0060_5_c_2012_29			
Action/Comments				
Inspector Comments: Existing riprap protection is properly maintained and is undamaged. Riprap is clearly visible on both sides.

View of the type of riprap that lines the channel, 2018.

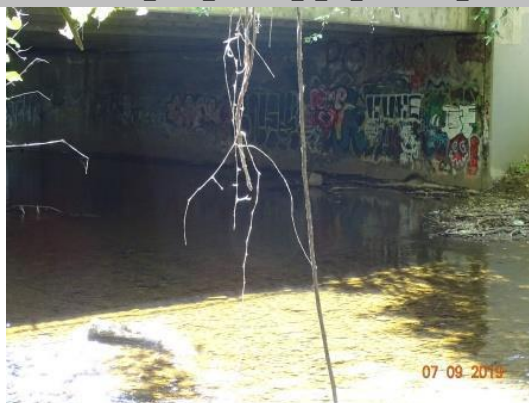
Photo 2 of 2 : CH_2019_NA0060_5_34_20190715_00047.jpg

No visible revetment left bank, 2019.

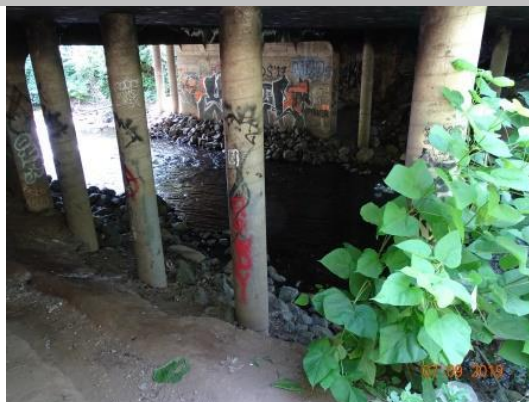
Photo 1 of 1 : CH_2019_NA0060_5_44_20190715_00050.jpg

Check Point / View				
Hwy 32 / Up (cont)				
Rating **	A	Issue No.	44	GPS Lat/Long
Issue Type +	Ma	Location *		39.725776 °
Category	Rivers, Channels & Designated Flood			-121.851207 °
Item	Revetments			
DWR ID	DWR_NA0060_5_c _ 2012_44			
Action/Comments				
Inspector Comments: Revetments present both sides of channel.

View of revetment around piers both right bank and left bank, 2019.

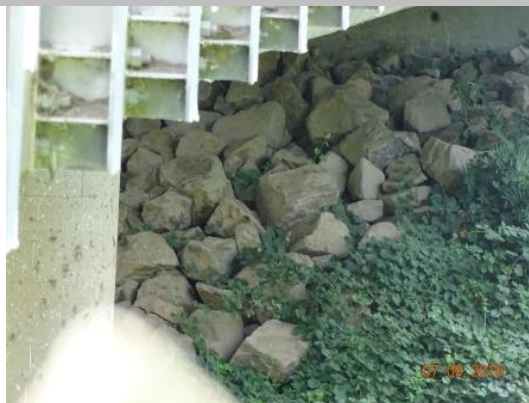
Photo 1 of 2 : CH_2019_NA0060_5_54_20190715_00057.jpg

Inspector Comments: Riprap is covered with vegetation. Trees and other vegetation growth should be managed/removed from riprap.

View of the revetment right bank that is over grown with vegetation, 2019.

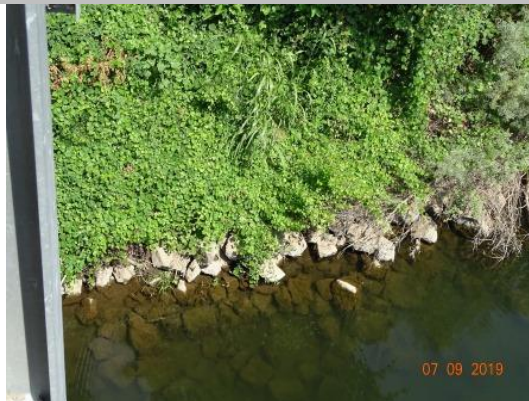
Photo 2 of 2 : CH_2019_NA0060_5_54_20190715_00056.jpg

View of the revetment left bank that is over grown with vegetation, 2019.

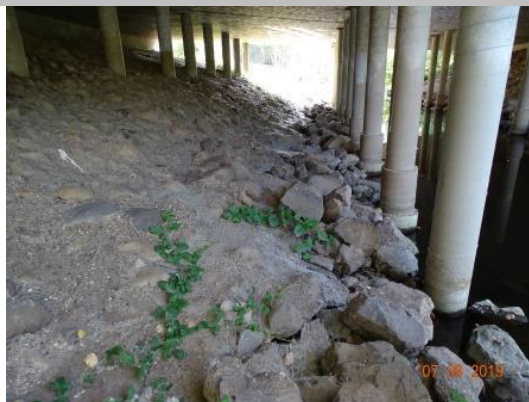
Photo 1 of 2 : CH_2019_NA0060_6_14_20190715_00069.jpg

Inspector Comments: Revetment under bridge, both right and left abutments.

View of revetment right bank at bridge abutment, 2019.

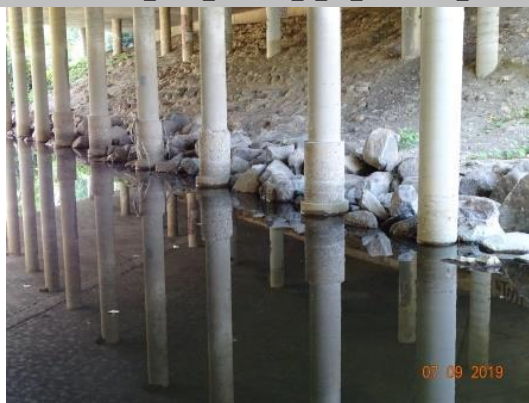
Photo 2 of 2 : CH_2019_NA0060_6_14_20190715_00070.jpg

View of revetment left bank at bridge abutment, 2019.

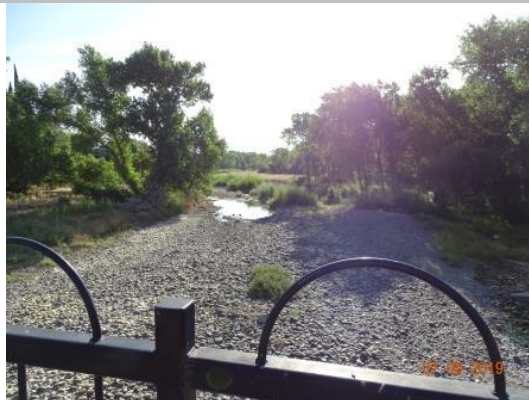
Photo 1 of 1 : CH_2019_NA0060_6_21_20190715_00071.jpg

Inspector Comments: Minimal, scattered obstructions or vegetation exists however the flow is not impeded.

View of the channel facing upstream from the bridge, 2019.

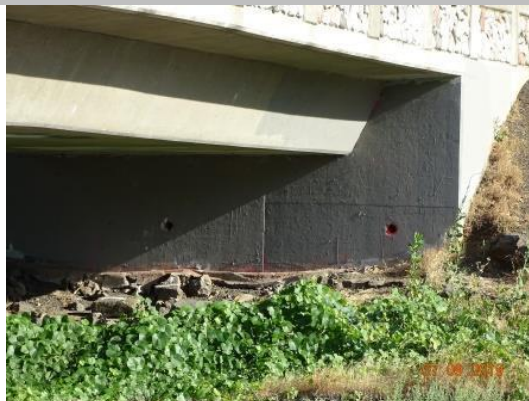
Photo 1 of 2 : CH_2019_NA0060_6_24_20190715_00073.jpg

Inspector Comments: Riprap at the foot of the bridge seems to have slid down towards the channel in previous high water events, but the capacity of the channel is not affected.

View looking at the right bank abutment very little revetment remaining, 2019.

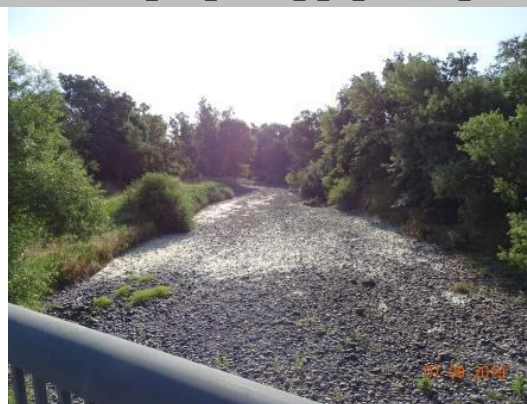
Photo 1 of 1 : CH_2019_NA0060_6_31_20190715_00075.jpg

Rating **	A	Issue No.	31	GPS Lat/Long
Issue Type +	Ma	Location *		39.752730 °
Category	Rivers, Channels & Designated Flood			-121.824560 °
Item	Vegetation & Obstructions			
DWR ID	DWR_NA0060_6_c_2012_31			
Action/Comments				
Inspector Comments: Minimal, scattered log obstructions exists however the flow is not impeded.

View of the channel facing upstream from the bridge, 2019.

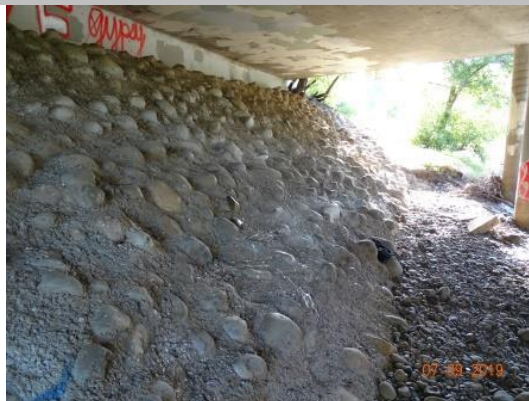
Photo 1 of 2 : CH_2019_NA0060_6_34_20190715_00077.jpg

Rating **	A	Issue No.	34	GPS Lat/Long
Issue Type +	Ma	Location *		39.752730 °
Category	Rivers, Channels & Designated Flood			-121.824560 °
Item	Revetments			
DWR ID	DWR_NA0060_6_c_2012_34			
Action/Comments				
Inspector Comments: Revetment on slope up to the bridge abutment, both sides.

View of right bank, revetment on slope up to the bridge abutment, 2019.

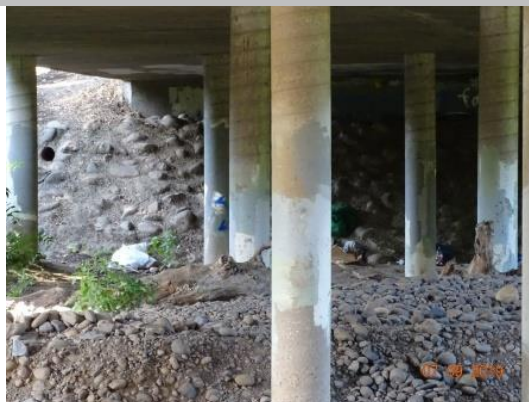
Photo 2 of 2 : CH_2019_NA0060_6_34_20190715_00076.jpg

Inspector Comments: Revetment on slope up to the bridge abutment, both sides.

View of left bank, revetment on slope up to the bridge abutment, 2019.

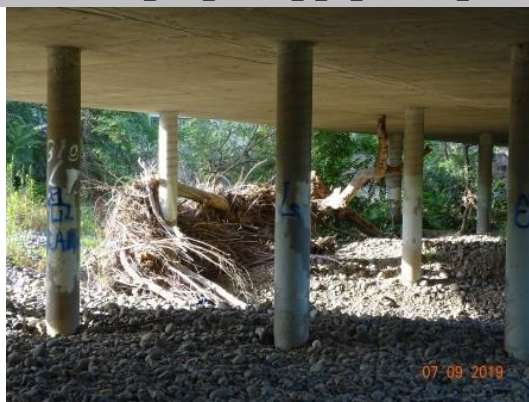
Photo 1 of 1 : CH_2019_NA0060_6_35_20190715_00080.jpg

Rating **	M	Issue No.	35	GPS Lat/Long
Issue Type +	Ma	Location *		39.752730 °
Category	Rivers, Channels & Designated Flood			-121.824560 °
Item	Encroachments			
DWR ID	DWR_NA0060_6_c_2012_35

Inspector Comments: Debris present within the project easement area needs to be removed from pilings, 2019.

View of debris present within the project easement area that needs to be removed from pilings, 2019.

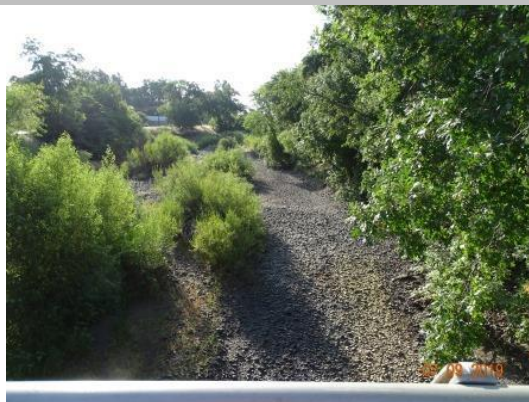
Photo 1 of 1 : CH_2019_NA0060_6_41_20190715_00079.jpg

Check Point / View				
5th Ave / Up				
Rating **	A	Issue No.	41	GPS Lat/Long
Issue Type +	Ma	Location *		39.753307 °
Category	Rivers, Channels & Designated Flood			-121.829234 °
Item	Vegetation & Obstructions			
DWR ID	DWR_NA0060_6_c_2012_41			
Action/Comments				
Inspector Comments: Minimal, scattered obstructions or vegetation exists however the flow is not impeded.

View of the channel facing upstream from the bridge, 2019.

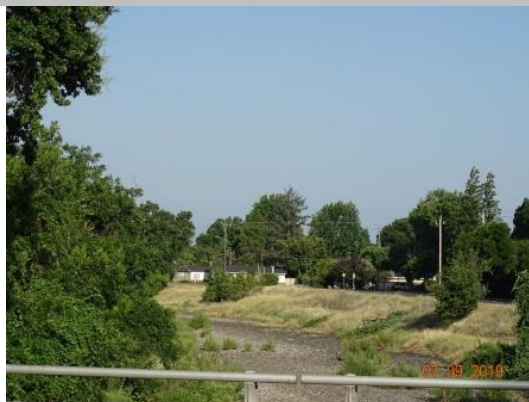
Photo 1 of 1 : CH_2019_NA0060_6_46_20190715_00084.jpg

Rating **	A	Issue No.	46	GPS Lat/Long
Issue Type +	Ma	Location *		39.753307 °
Category	Rivers, Channels & Designated Flood			-121.829234 °
Item	Vegetation & Obstructions			
DWR ID	DWR_NA0060_6_c_2012_46			
Action/Comments				
Inspector Comments: Minimal, scattered obstructions or vegetation exists however the flow is not impeded.

View of channel facing downstream from the bridge, 2019.

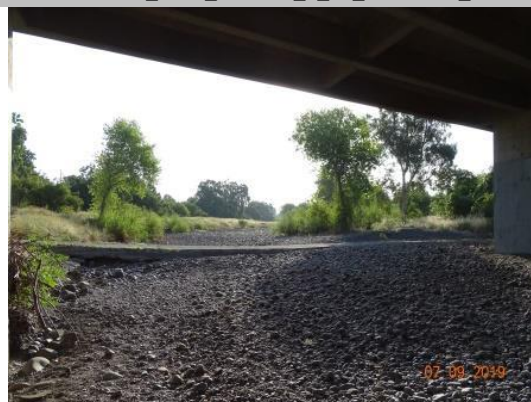
Photo 1 of 1 : CH_2019_NA0060_6_91_20190715_00085.jpg

Check Point / View				
Highway 99 / Up				
Rating **	A	Issue No.	91	GPS Lat/Long
Issue Type +	Ma	Location *		39.751220 °
Category	Rivers, Channels & Designated Flood			-121.840042 °
Item	Vegetation & Obstructions			
DWR ID	DWR_NA0060_6_c_2015_91			
Action/Comments				
Inspector Comments: Minimal, scattered obstructions or vegetation exists however the flow is not impeded.

View of the channel facing upstream from the channel, 2019.

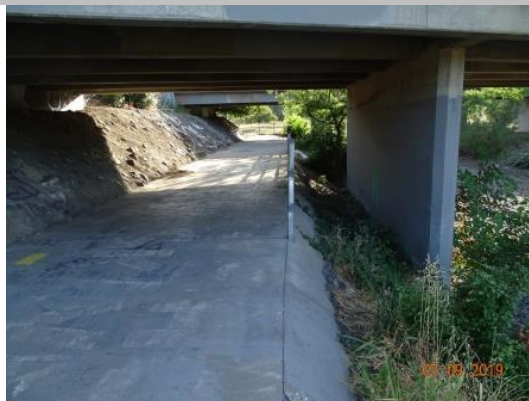
Photo 1 of 2 : CH_2019_NA0060_6_99_20190715_00086.jpg

Rating **	A	Issue No.	99	GPS Lat/Long
Issue Type +	Ma	Location *		39.751220 °
Category	Rivers, Channels & Designated Flood			-121.840042 °
Item	Revetments			
DWR ID	DWR_NA0060_6_c _ 2015_99			
Action/Comments				
Inspector Comments: Existing riprap protection is properly maintained and is undamaged. Riprap clearly visible both sides.

View of right bank revetment looking upstream on slope up to the bridge abutment, 2019.

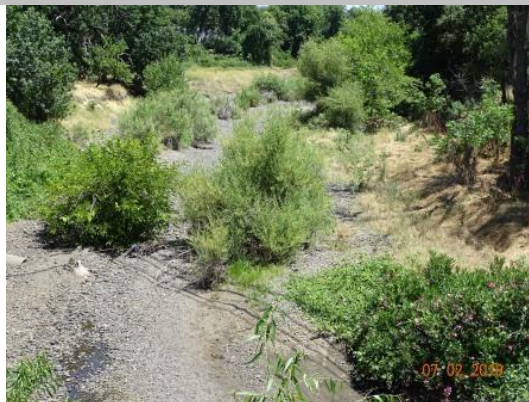
Photo 1 of 1 : CH_2019_NA0060_6_111_20190715_00090.jpg

Rating **	A	Issue No.	111	GPS Lat/Long
Issue Type +	Ma	Location *		39.750979 °
Category	Rivers, Channels & Designated Flood			-121.844711 °
Item	Vegetation & Obstructions			
DWR ID	DWR_NA0060_6_c_2015_111			
Action/Comments				
Inspector Comments: Minimal, scattered obstructions or vegetation exists however the flow is not impeded.

View of the channel looking upstream, 2019.

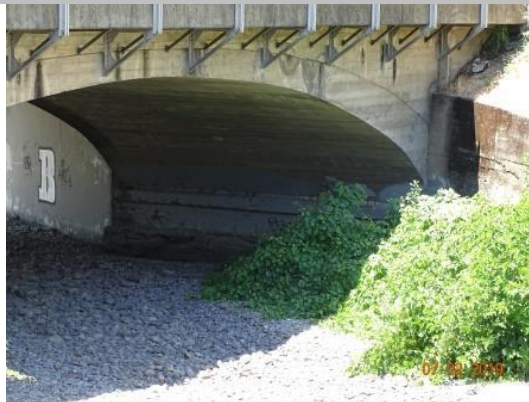
Photo 1 of 3 : CH_2019_NA0060_6_54_20190715_00097.jpg

Rating **	N	Issue No.	54 (cont)	GPS Lat/Long
Issue Type +	Ma	Location *		39.749458 °
Category	Rivers, Channels & Designated Flood			-121.854296 °
Item	Revetments			
DWR ID	DWR_NA0060_6_c _ 2012_54

View of the right abutment, no revetment exist, 2019.

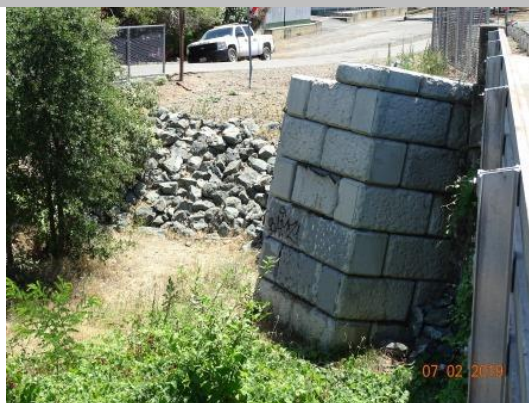
Photo 3 of 3 : CH_2019_NA0060_6_54_20190715_00095.jpg

View of the left bank revetment next to the abutment, there is no revetment in the channel at the abutment, 2019.

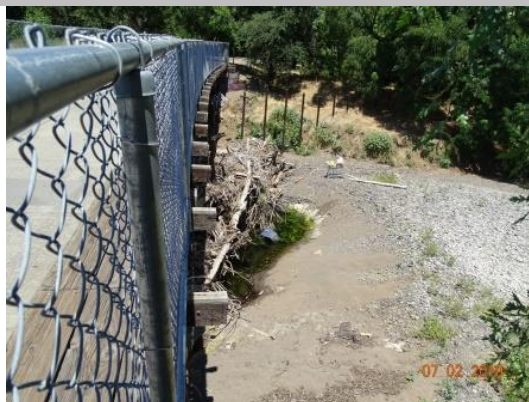
Photo 2 of 2 : CH_2019_NA0060_6_55_20190715_00092.jpg

Rating **	M	Issue No.	55 (cont)	GPS Lat/Long
Issue Type +	Ma	Location *		39.749458 °
Category	Rivers, Channels & Designated Flood			-121.854296 °
Item	Encroachments			
DWR ID	DWR_NA0060_6_c_2012_55

Closer view of debris caught in and around the foot bridge upstream, 2019.

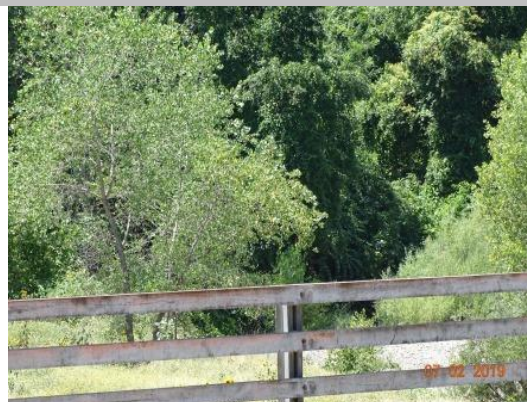
Photo 1 of 1 : CH_2019_NA0060_6_56_20190715_00098.jpg

Rating **	M	Issue No.	56	GPS Lat/Long
Issue Type +	Ma	Location *		39.749458 °
Category	Rivers, Channels & Designated Flood			-121.854296 °
Item	Vegetation & Obstructions			
DWR ID	DWR_NA0060_6_c_2012_56			
Action/Comments				
Inspector Comments: Vegetation and scattered obstructions exists and the flow may be impeded.

View of the channel facing downstream, 2019.

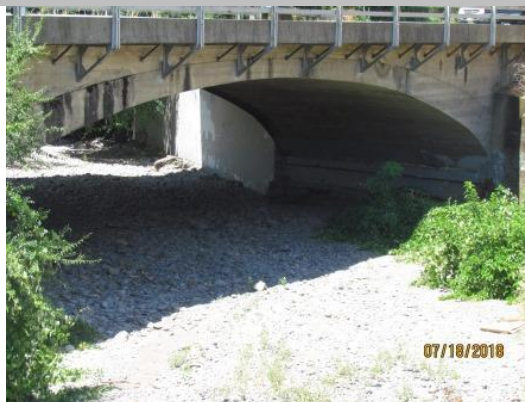
Photo 1 of 1 : CH_2019_NA0060_6_59_20190701_00034.jpg

Check Point / View				
Esplanade / Down (cont)				
Rating **	N	Issue No.	59	GPS Lat/Long
Issue Type +	Ma	Location *		39.749458 °
Category	Rivers, Channels & Designated Flood			-121.854296 °
Item	Revetments			
DWR ID	DWR_NA0060_6_c_2012_59			
Action/Comments				
Inspector Comments: There is no revetment in the channel at the abutments.

View of the right bank looking downstream, there is no revetment in the channel at the abutment, 2018.

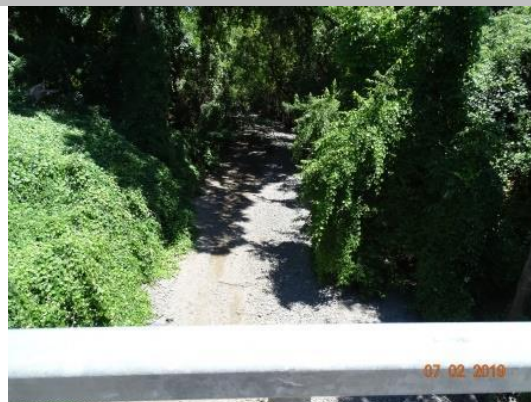
Photo 1 of 1 : CH_2019_NA0060_6_101_20190715_00099.jpg

Rating **	A	Issue No.	101	GPS Lat/Long
Issue Type +	Ma	Location *		39.749209 °
Category	Rivers, Channels & Designated Flood			-121.865682 °
Item	Vegetation & Obstructions			
DWR ID	DWR_NA0060_12_c_2015_101			
Action/Comments				
Inspector Comments: Minimal, scattered obstructions and vegetation exists however the flow does not look to be impeded.

View of the channel looking upstream, 2019.

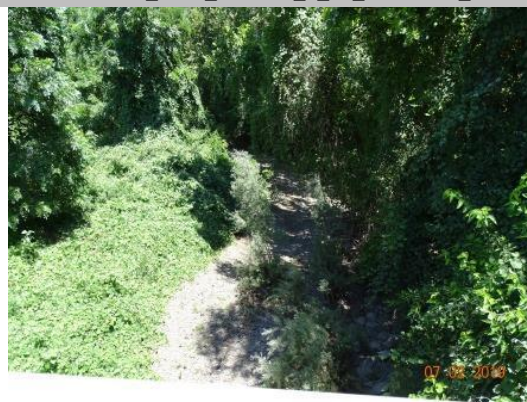
Photo 1 of 1 : CH_2019_NA0060_6_61_20190715_00103.jpg

Check Point / View				
Hwy 32 / Up				
Rating **	M	Issue No.	61	GPS Lat/Long
Issue Type +	Ma	Location *		39.741277 °
Category	Rivers, Channels & Designated Flood			-121.881402 °
Item	Vegetation & Obstructions			
DWR ID	DWR_NA0060_6_c_2012_61			
Action/Comments				
Inspector Comments: Vegetation exists and may impede the flow.

View of the channel looking upstream, 2019.

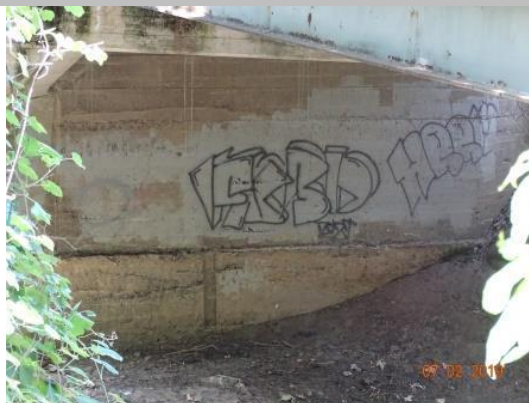
Photo 1 of 2 : CH_2019_NA0060_6_74_20190715_00109.jpg

Rating **	N	Issue No.	74	GPS Lat/Long
Issue Type +	Ma	Location *		39.735560 °
Category	Rivers, Channels & Designated Flood			-121.890970 °
Item	Revetments			
DWR ID	DWR_NA0060_6_c_2012_74			
Action/Comments				
Inspector Comments: No revetments present.

View of right abutment with no revetment, 2019.

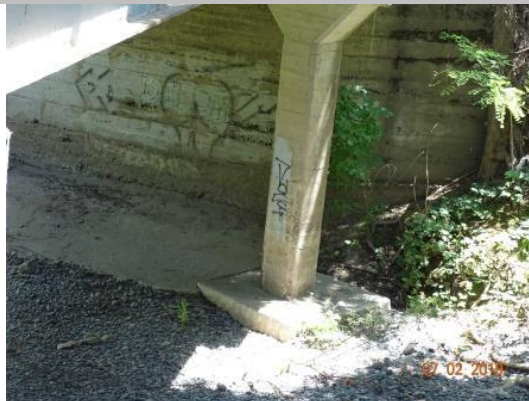
Photo 2 of 2 : CH_2019_NA0060_6_74_20190715_00110.jpg

Rating **	N	Issue No.	74 (cont)	GPS Lat/Long
Issue Type +	Ma	Location *		39.735560 °
Category	Rivers, Channels & Designated Flood			-121.890970 °
Item	Revetments			
DWR ID	DWR_NA0060_6_c_2012_74

View of left abutment with no revetment, 2019.

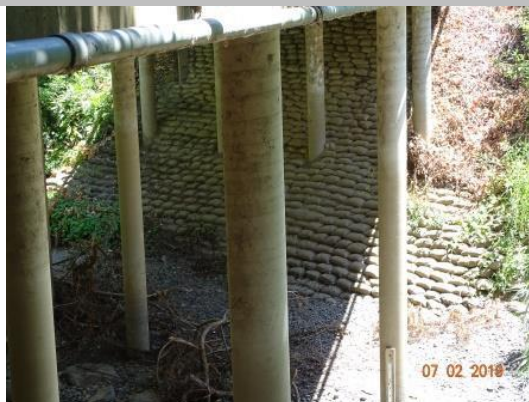
Photo 2 of 2 : CH_2019_NA0060_6_84_20190715_00114.jpg

Rating **	A	Issue No.	84 (cont)	GPS Lat/Long
Issue Type +	Ma	Location *		39.722724 °
Category	Rivers, Channels & Designated Flood			-121.912363 °
Item	Revetments			
DWR ID	DWR_NA0060_6_c_2012_84

View of concrete sandbag revetment at bridge abutments, left bank, 2019.

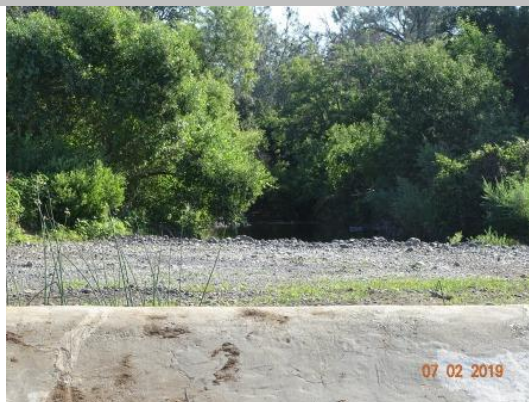
Photo 1 of 1 : CH_2019_NA0060_12_1_20190710_00046.jpg

Rating **	A	Issue No.	1	GPS Lat/Long
Issue Type +	Ma	Location *		39.733681 °
Category	Rivers, Channels & Designated Flood			-121.771865 °
Item	Vegetation & Obstructions			
DWR ID	DWR_NA0060_12_c_2012_1			
Action/Comments				
Inspector Comments: Minimal, scattered obstructions and vegetation. The flow is not impeded.

This is the upstream view from the Little Chico Weir, 2019.

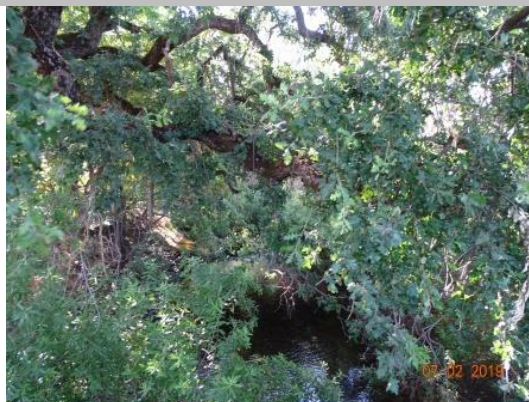
Photo 1 of 1 : CH_2019_NA0060_12_114_20190710_00050.jpg

Inspector Comments: The vegetation overhangs the channel but does not appear to impede the flows.

View looking upstream from the bridge of the overhanging vegetation, 2019.

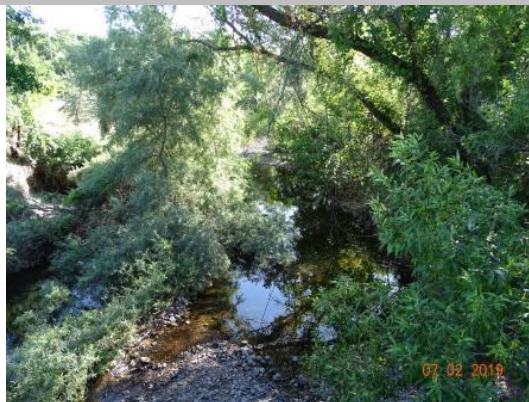
Photo 1 of 1 : CH_2019_NA0060_12_115_20190710_00051.jpg

Inspector Comments: Minimal, scattered obstructions or vegetation. The flow is not impeded.

View looking upstream at the channel from the bridge, 2019.

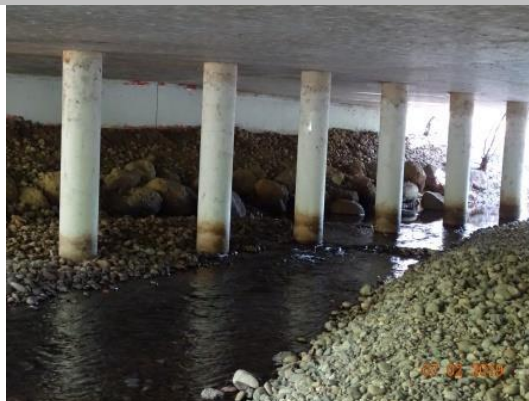
Photo 1 of 2 : CH_2019_NA0060_12_24_20190710_00052.jpg

Inspector Comments: Revetments present.

View of revetment on right bank, 2019.

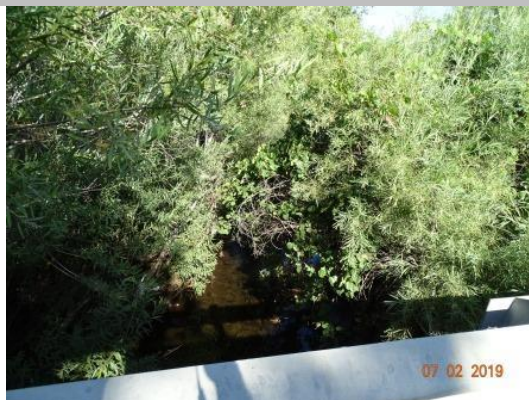
Photo 1 of 1 : CH_2019_NA0060_12_21_20190710_00049.jpg

Rating **	M	Issue No.	21	GPS Lat/Long
Issue Type +	Ma	Location *		39.737400 °
Category	Rivers, Channels & Designated Flood			-121.804530 °
Item	Vegetation & Obstructions			
DWR ID	DWR_NA0060_12_c_2012_21			
Action/Comments				
Inspector Comments: Scattered bushes and vegetation may impede the flow of the channel.

View of the channel from the bridge facing downstream, 2019.

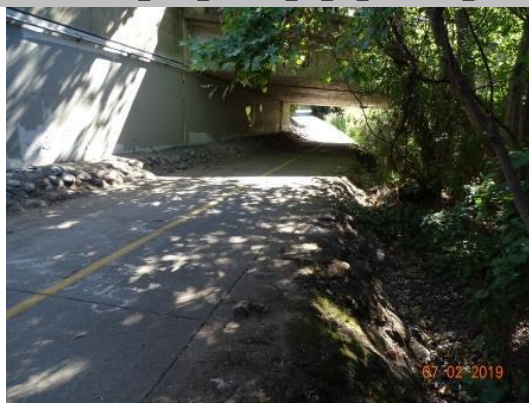
Photo 3 of 3 : CH_2019_NA0060_12_34_20190710_00058.jpg

View of the revetment along the abutment of the bridge on the right bank looking upstream, 2019.

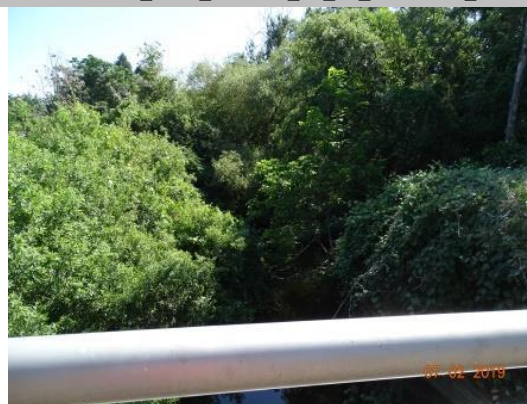
Photo 1 of 1 : CH_2019_NA0060_12_82_20190710_00060.jpg

Inspector Comments: There is vegetation in the channel and it appears to potentially impede the flow.

View of the channel from the bridge facing upstream, 2019.

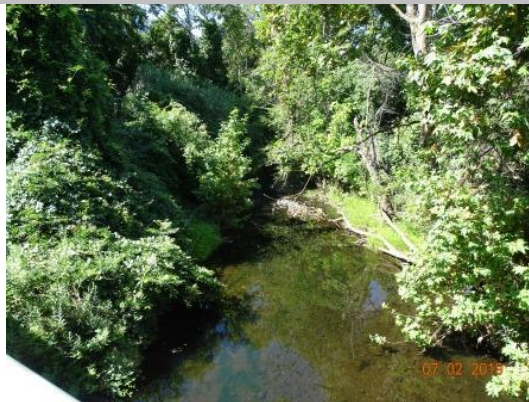
Photo 1 of 1 : CH_2019_NA0060_12_89_20190710_00061.jpg

Inspector Comments: There is some vegetation on the banks, but the channel is clear and the flow does not appear to be impeded.

View of the channel from the bridge facing downstream, 2019.

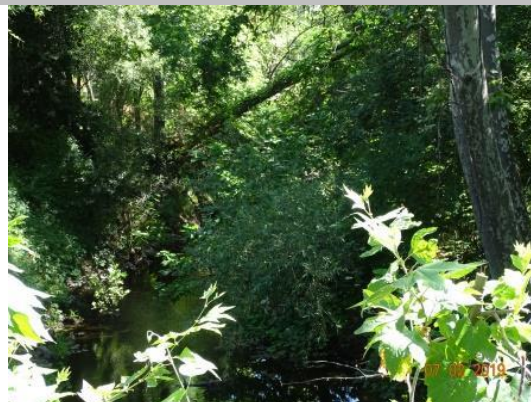
Photo 1 of 1 : CH_2019_NA0060_12_41_20190710_00064.jpg

Inspector Comments: There is vegetation in the channel and overhanging the channel, the flow could be impeded.

View of the channel from the bridge facing upstream, 2019.

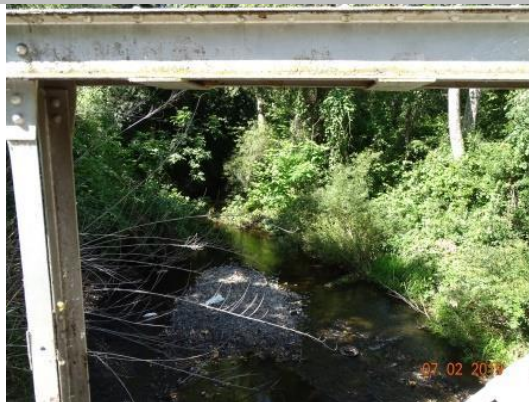
Photo 1 of 1 : CH_2019_NA0060_12_46_20190710_00067.jpg

Inspector Comments: There is vegetation in the channel, overhanging the channel, and arundo. The flow does appear slightly impeded.

View of the channel from the bridge facing downstream, 2019.

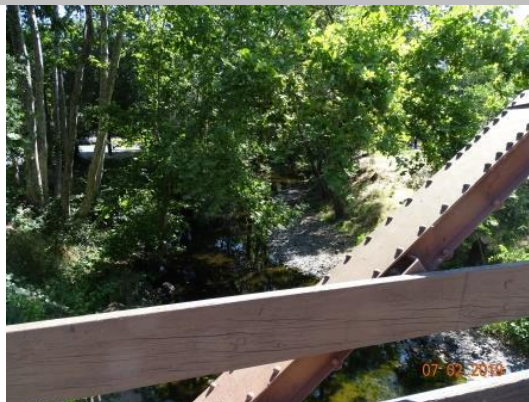
Photo 1 of 1 : CH_2019_NA0060_12_51_20190710_00068.jpg

Inspector Comments: There is vegetation over the channel, it does not appear to impeded the flow.

View of the channel from the bridge facing upstream, 2019.

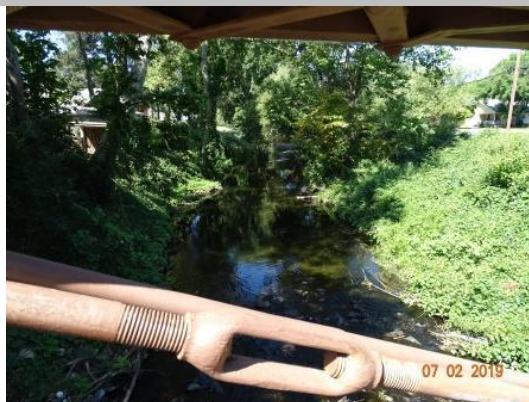
Photo 1 of 1 : CH_2019_NA0060_12_56_20190710_00071.jpg

Rating **	A	Issue No.	56	GPS Lat/Long
Issue Type +	Ma	Location *		39.726792 °
Category	Rivers, Channels & Designated Flood			-121.829713 °
Item	Vegetation & Obstructions			
DWR ID	DWR_NA0060_12_c_2012_56			
Action/Comments				
Inspector Comments: There is vegetation over the channel, the flow does not appear impeded.

View of the channel from the bridge facing downstream, 2019.

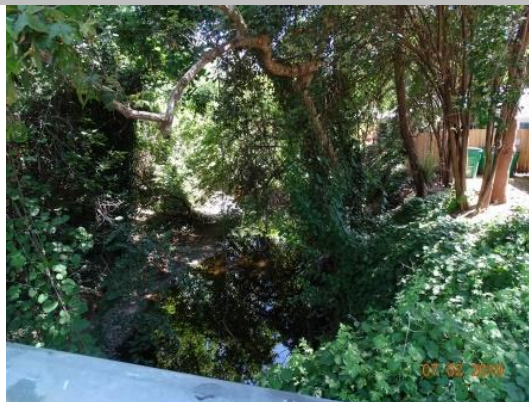
Photo 1 of 1 : CH_2019_NA0060_12_94_20190710_00076.jpg

Inspector Comments: Scattered obstructions and vegetation over channel, should not impede the flow of the channel.

View of the channel from the bridge facing upstream, 2019.

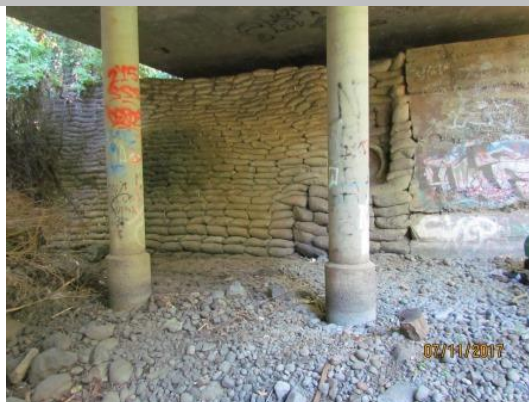
Photo 2 of 2 : CH_2019_NA0060_12_97_20190701_00041.jpg

Rating **	A	Issue No.	97 (cont)	GPS Lat/Long
Issue Type +	Ma	Location *		39.720476 °
Category	Rivers, Channels & Designated Flood			-121.838990 °
Item	Revetments			
DWR ID	DWR_NA0060_12_c_2015_97			
Action/Comments				
Inspector Comments: Sandbag revetment on right bank of abutment, no revetment on left bank and none needed.

View of sandbag revetment on right bank of abutment, 2017.

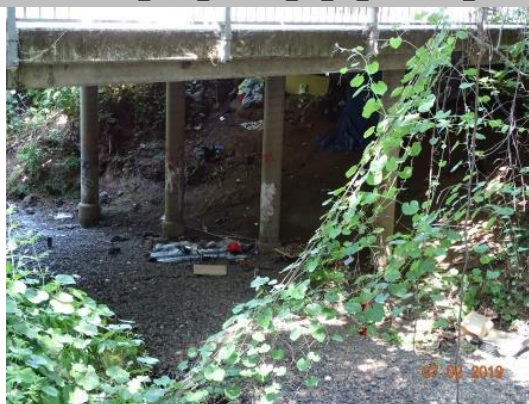
Photo 1 of 1 : CH_2019_NA0060_12_98_20190710_00081.jpg

Rating **	A	Issue No.	98	GPS Lat/Long
Issue Type +	Ma	Location *		39.720476 °
Category	Rivers, Channels & Designated Flood			-121.838990 °
Item	Encroachments			
DWR ID	DWR_NA0060_12_c_2015_98			
Action/Comments				
Inspector Comments: Trash, debris from homeless present within the channel easement, 2019

View of trash and debris from the homeless living under the bridge, 2019.

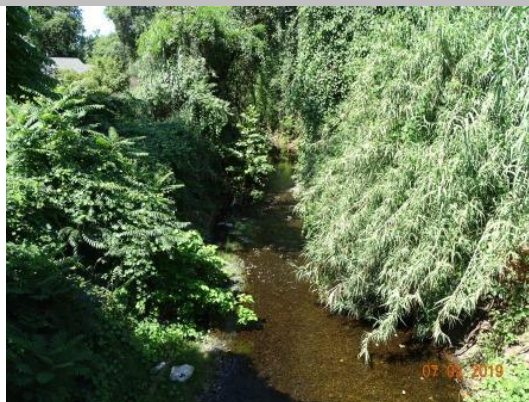
Photo 1 of 1 : CH_2019_NA0060_12_109_20190710_00086.jpg

Inspector Comments: The channel appeared free of any vegetation that would impede the flow. Although the Arundo should be removed before it chokes down the channel.

View of the channel from the bridge facing upstream, 2019.

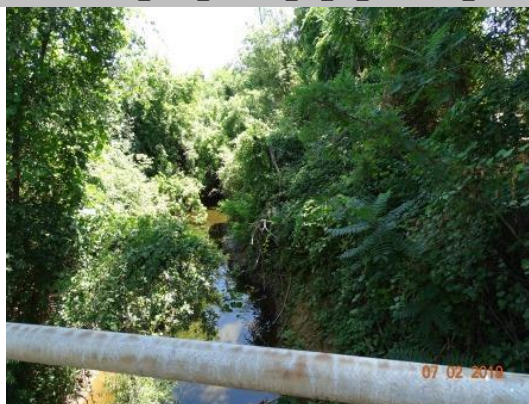
Photo 1 of 1 : CH_2019_NA0060_12_71_20190710_00087.jpg

Inspector Comments: Scattered obstructions and vegetation, and may impede the flow of the channel.

View of the channel from the bridge facing upstream, 2019.

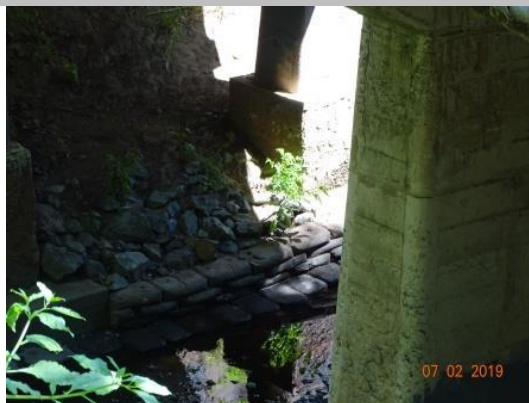
Photo 1 of 2 : CH_2019_NA0060_12_74_20190710_00090.jpg

Inspector Comments: Concrete filled sandbags used for riprap at bridge abutments on both sides.

View of concrete sandbag revetment on the channels edge left bank, 2019.
